**FLORIDA DEPARTMENT OF
ENVIRONMENTAL PROTECTION**

STRATEGIC BEACH MANAGEMENT PLAN

SOUTHWEST GULF COAST REGION

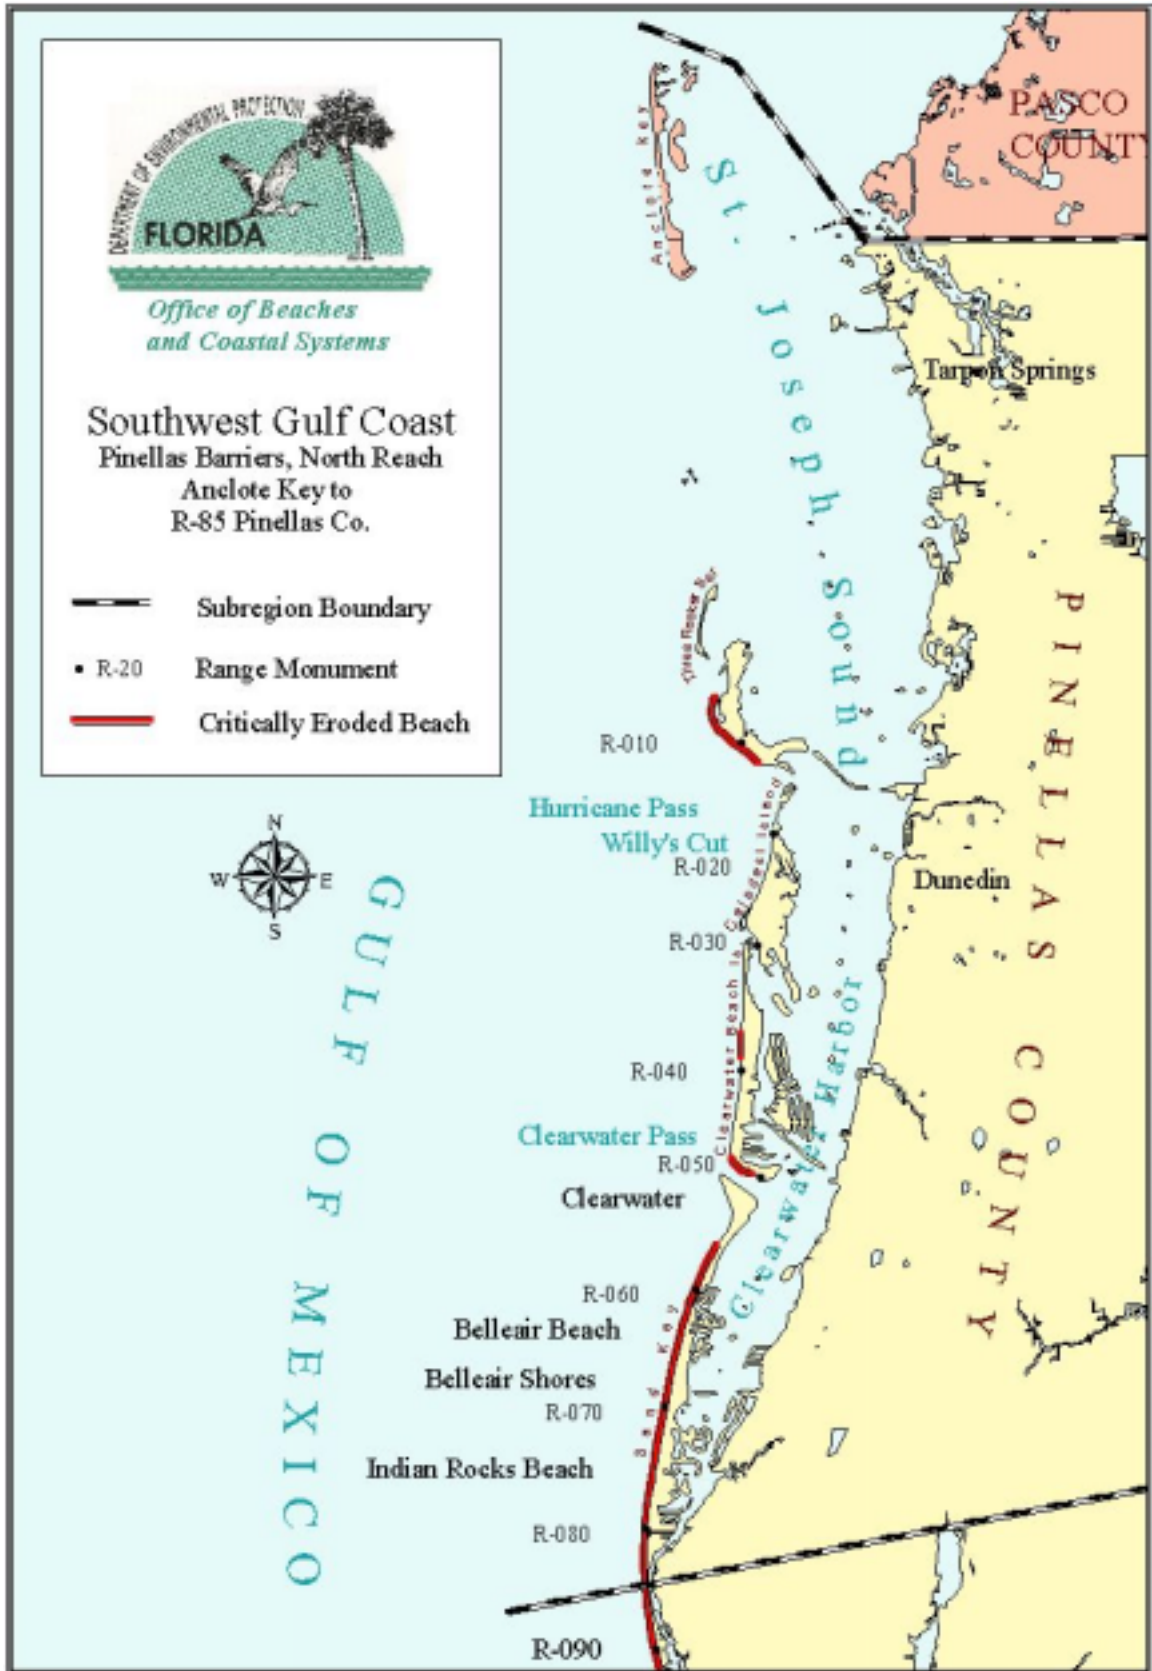
Figure SW.1: Pinellas Barriers North Reach

The **Pinellas Barriers North Reach** subregion extends from Anclote Key in Pasco County to the midpoint of Sand Key (R85) in Pinellas County, as shown on Figure SW.1. The area includes Anclote Key, Three Rooker Bar, Honeymoon Island, Caladesi Island, Clearwater Beach Island, and the northern portion of Sand Key. The islands are separated from the mainland by St. Joseph Sound, Clearwater Harbor, and the Intracoastal Waterway. The inlets include Hurricane Pass and Clearwater Pass. There are 7.8 miles of critically eroded beach in this subregion. Erosion is attributed to winter frontal systems, tropical storms and hurricanes, and the effects of the inlets. The most erosive storms in recent years were a subtropical storm of 1982, Hurricane Elena and Tropical Storm Juan in 1985, an extratropical storm of March 1993, and Tropical Storm Josephine in 1996.
